Asbestos Survey Report

**Infant Health Centre
4 Temple Street
Victoria Park, 6100**

Prepared For: Town of Victoria Park
99 Shepperton Road
Victoria Park, 6100
Report Number: AP2019-145
Report Version: 1
Report Date: 26/05/2019

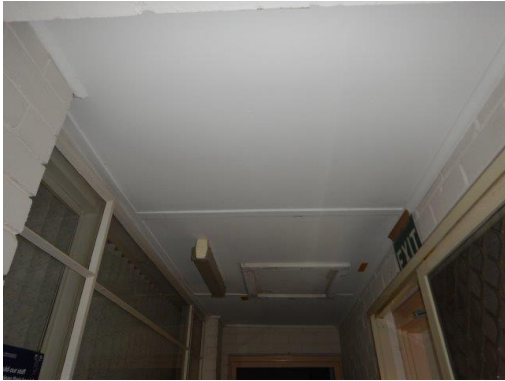
Item Number: 65301

Infant Health Centre																
Item No.	Level/Area	Room/ Location	Application	Description	Extent	Approach	Sample Ref.	Asbestos Type(s)	Friability	Surface Properties	Product Type / Material	Condition	Fibre Release Risk	Disturbance Potential	Recommended Action	Comments
65301	Ground Floor	Main Entrance (61)	Fibre cement ceiling lining	Cement Sheet (Flat)	--	S	G2135	Crocidolite	Non-friable	Sealed cements	Fibre cement	Good condition	Low	Rare	Manage in accordance with AMP	Roof void access hatch sealed with paint, cannot force open without damage
65302	Ground Floor	To Building (61)	Fibre cement eaves lining	Cement Sheet (Flat)	--	X	G2135	Crocidolite	Non-friable	Sealed cements	Fibre cement	Good condition	Low	Rare	Manage in accordance with AMP	
65303	Ground Floor	To eaves lining (61)	Fibre cement joint cover strips	Cement Product	--	S	G2136	Crocidolite	Non-friable	Sealed cements	Fibre cement	Good condition	Low	Rare	Manage in accordance with AMP

Fibre cement ceiling lining - Main Entrance (61)

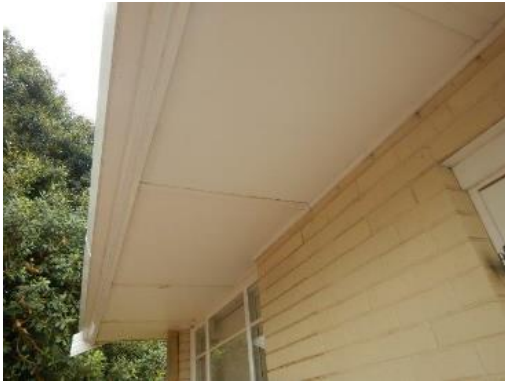
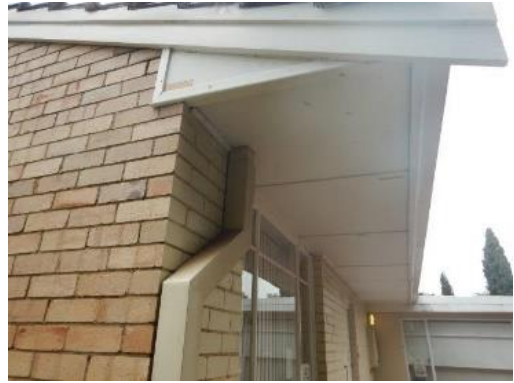
Item Number: 65302

Fibre cement eaves lining - To Building Perimeter (61)

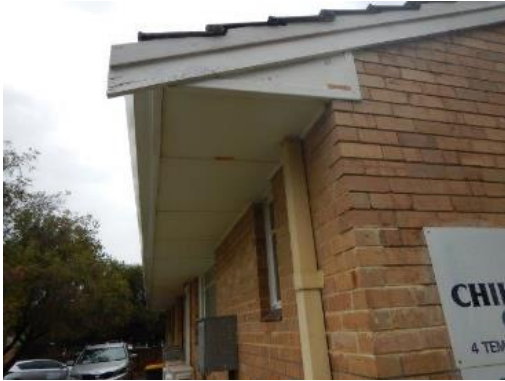
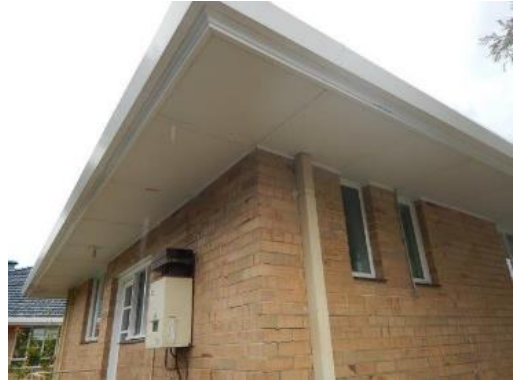
Item Number: 65303

Fibre cement joint cover strips - To eaves lining (61)
