AQUA LIFE CENTRE

BUILDING CONDITION ASSESSMENT AND STRATEGIC ASSET REVIEW

April 2019

TOWN OF
VICTORIA PARK

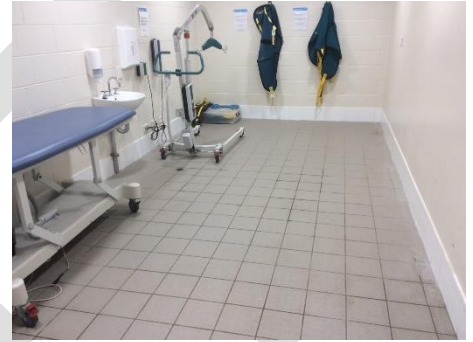
Figure 7 – Treatment Room
(Hydrotherapy Pool)

- \ Centre management also advise that the treatment room within the hydrotherapy pool is insufficient (See Figure 7). Our measurements indicate this space is approximately 17m² and is used as a changing area for special needs/disabled patrons.

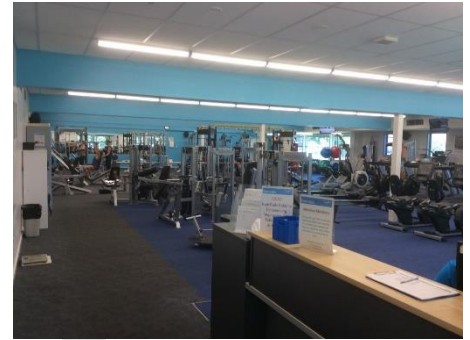
Figure 8 – Gymnasium

- Tinting to northern windows as well as windows at the gymnasium entrance to prevent afternoon sunlight. This will enable the window treatments to remain raised whilst providing an energy efficiency solution during the peak of summer when the air conditioning is constantly running.

- Gymnasium may have further expansion opportunities within the storage/ducting area under the grandstand seating of the 25m pool. Currently, this area only features one assessment room, which appears to have been considered post original design. Whilst this is unlikely to extend the main gym floor, it has the ability to provide more assessment/office accommodation as well as potentially remove items such as lockers from the main floor.

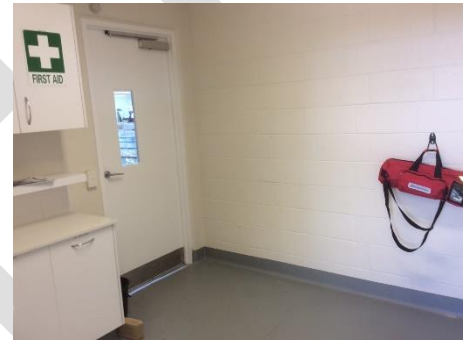
Figure 9 – First Aid Room

- \ The first aid room at Aqua Life is located off the main pool hall and is approximately 9m². This area would benefit from installation of a direct phone line. Centre management advise that the space is too small for its use, although it appears to be able to accommodate the balance of items required for a first aid space (See Figure 9).
- \ Staff workspaces are not ergonomically designed particularly within the administration and control room, overlooking the main pool hall.
- \ The hydrotherapy pool is not deep enough to undertake rehabilitation sessions.
- \ The plant room is difficult to access and maintain. The room is approximately 95m² and features the majority of the major pool heaters, pumps and filtration systems (See Figure 10).

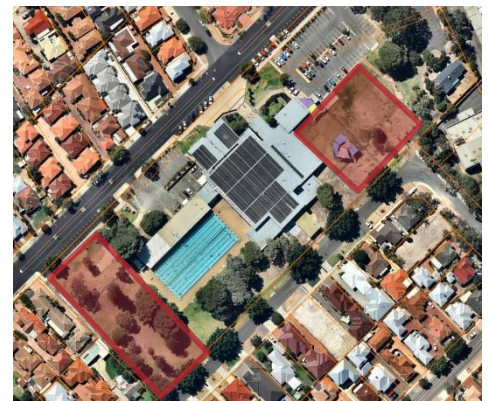
Figure 11 – Expansion Opportunities

- \ Should the need arise, there are potential expansion opportunities to both the East and West of the existing building (See Figure 11).
