LEISURE LIFE & COMMUNITY CENTRE

BUILDING CONDITION ASSESSMENT AND STRATEGIC ASSET REVIEW

April 2019

TOWN OF
VICTORIA PARK

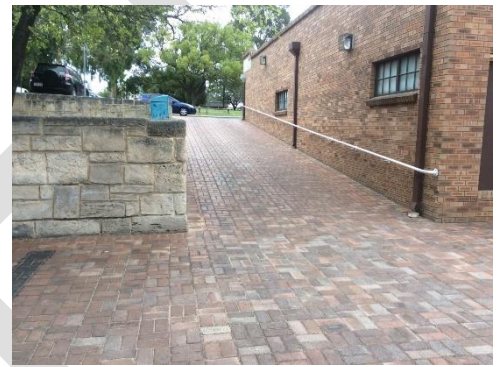
Figure 7 – Leisure Life Vehicle Access

- Vehicle access to the lower car park area (6 car bays) is via a 4m driveway from the main car park (See Figure 7). Access to the lower car park is poor with the entry essentially operating as a one-way driveway. In addition to this, given the usage of the facility (sport and recreation) and the increased likelihood that there will be a need for emergency services (ambulances), this creates a significant hinderance for access and parking close to the entry to the facility.
- Access to the first-floor squash courts is poor, particularly for disabled participants/spectators. The existing stairwell prevents access for those with mobility impairments.

- \ Scope and install security bollards at the front entry to prevent damage to the building by vehicles.
- \ Further investigate the requirement of a galvanised hand rail for the two car parking spaces at the top of the lower car park driveway.

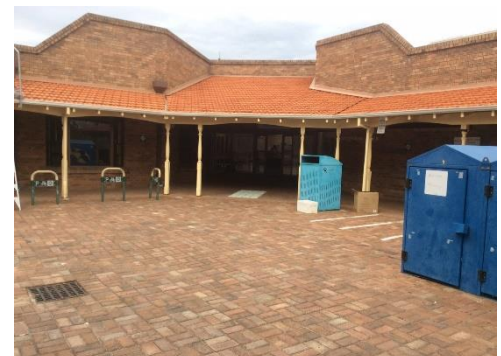
Figure 8 – Leisure Life Entry

- At the front of the Leisure Life building, there are six parking spaces, including two ACROD bays. The two ACROD bays appear constrained with little ability for other vehicles to be parked next to them when vehicles with side mobility access points are parked.

component. Whilst the CCTV system and cameras appear in good condition, centre management have advised that the cameras are now out of date and do not provide clear footage.

- \ Additional CCTV coverage to the lower carpark/front of building area.
- \ Replace existing lattice and gate in the atrium preventing safe/clear fire escape route from Activities Area 1.

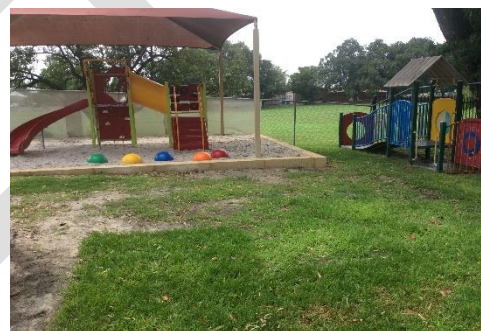
Figure 9 – Community Centre Playground

- \ During our consultation, Community Centre management requested the front façade glass to be inspected to see if it is shatterproof. This is considered a requirement risk as the centre is frequented by small children on a regular basis.

- \ Consider replacement of existing playground area fencing with that provided in the adjoining Leisure Life grassed area.
- \ Seek additional security measures, potentially installation of an additional fence/gate, to prevent displaced/homeless people sleeping in the verandah area at the front of the building.

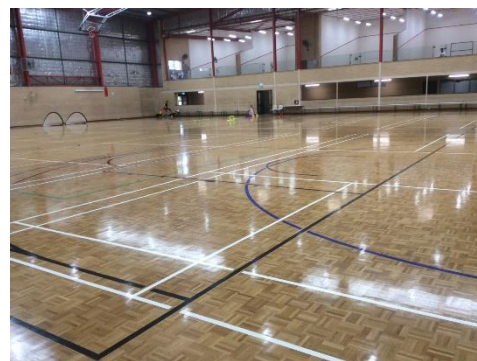
Figure 10 – Leisure Life Courts 1 & 2

- \ The ground fitness area is inadequate for classes. The space was originally conceived as a function hall and has been adapted for use as a group fitness space. Our measurements on site indicate that the area is approximately 180m².

- \ The upper floor RPM room is overcrowded and not big enough to accommodate current demand. In addition to this, the space is not visible to the public.

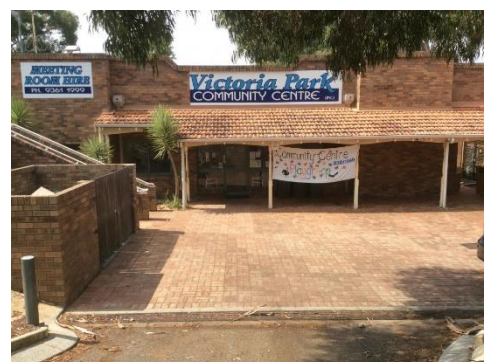
Figure 11 – Community Centre

- \ Similarly, to the Leisure Life Centre, the Community Centre is over 35 years old. Whilst aspects of the building have been maintained, majority of lighting replaced in 2018 and new heater in activities area, much of the building would benefit from modernisation/improvements, including:
 - Replacing majority of flooring, particularly vinyl flooring in the bathroom/toilet areas;
 - Rendering internal and external wall;
 - Repainting bathroom walls;
 - Replacing existing metal orb ceiling; and

- Replacing kitchen bench tops and cabinetry. On inspection, we were advised that the area would not pass Food Code/Guidelines. The area is used regularly for food preparation, with kids, and is outdated.

- \ Commit budget to replace the following components in the short term:
 - Replacing majority of flooring, particularly vinyl flooring in the bathroom/toilet areas;
