Pedestrian access - Shepparton Road Underpass [ramp & handrails]

Town of Victoria Park

Shepparton Road Underpass, Victoria Park

13 February 2024

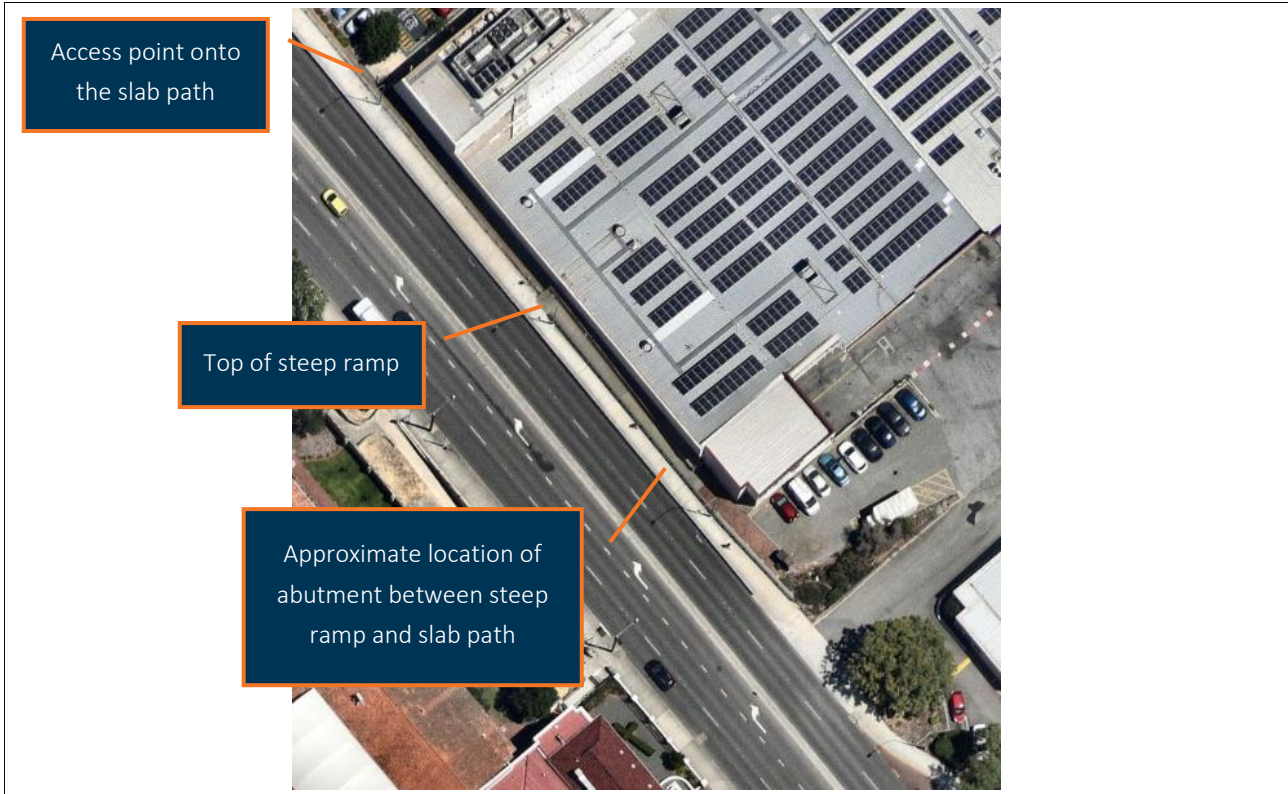
Figure 1: Points of reference informing this report

The main points of reference informing this report are shown in the Nearmap snapshot [Figure 1] below.

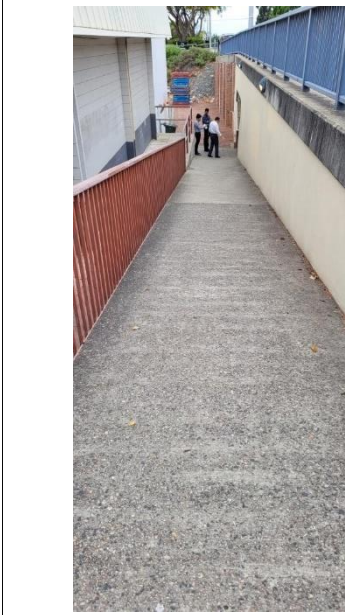
Figure 2: MRWA steep ramp

- The [steep/existing] pedestrian ramp structure [Figure 2] and underpass [Figure 3] are a Main Roads Western Australia [MRWA] asset, maintained by the Town of Victoria Park.

- On assessment, the ramp was assessed as having a gradient of 1:7 for a length of 30 metres (where an Australian Standards compliant pedestrian ramp requires a gradient no steeper than 1:14, with interval landings at distances no greater than 9 metres, with the pedestrian ramp furnished with warning tactile ground surface indicators at the top and base and handrails installed to both sides). The MRWA ramp does not meet any of these requirements. It is understood due to site constraints the ramp cannot be remediated to achieve a compliant gradient with landings at the required 9 metre intervals, thus the steep ramp will be retained as is.

- This ramp is patently not compliant as a pedestrian ramp, and I would suggest is wholly unsuitable for use by a manual or powered wheelchair user due to the non-compliant, lengthy, steep gradient.
- There were no barriers to access identified regarding the pedestrian underpass.

No.	Findings	Risk assessment	Recommendation & reference
1.	MRWA steep ramp has a gradient of 1:7 for a length of 30 metres, without interval (rest) landings or handrails.	<p>The steepness of the ramp, without necessary flat landings poses:</p> <ul style="list-style-type: none"> • A significant fall/stumble hazard to all pedestrians including persons with ambulant disability or other medical condition or neurological disorder who is walking down the ramp. • A significant risk in descent for a wheelchair user as there is no rest landing and the steepness will result in increased momentum and potential loss of control for a manual wheelchair user. • Additional to this risk in descent is the risk to other pedestrians or persons emerging from the underpass from being struck by an uncontrolled wheelchair / wheeled mobility device. 	<p>As a high priority:</p> <p>1.1 Install warning signage at the top of the ramps informing pedestrians of the steep gradient and unsuitability for wheeled devices (wheelchairs, prams, wheeled walkers).</p> <p>1.2 Provide directional signage at the entrance to the top ramp landing [inclusive of the international symbol of access and a pram symbol / aged person symbol and a directional arrow], directing pedestrians towards the Duncan Street footpath.</p> <p>1.3 Provide warning signage at the base of the steep ramp to direct any pedestrian who is a wheelchair user who has arrived at the base of the steep ramp to take an alternate route to the shopping centre / Albany Hwy, e.g. via the Shepparton Road footpath / in front of Services Australia.</p> <p>1.4 On the Ursula Frayne side of Shepparton Road, provide warning signage at the top of the ramp that advises pedestrians the ramp/underpass is not a suitable accessway to the Victoria Park (Vicinity) Shopping Centre.</p> <p>1.5 Prevent wheelchair access onto the steep ramp by installing a bollard at the top and base, reducing the gap onto the ramp to be less than 740mm [AS1428.1 2009 Figure 1 (a)]</p>

2.	MRWA steep ramp is not furnished with handrails to both sides.	The non-provision of handrails to both sides of the steep ramp renders pedestrians ascending/descending the ramp unsupported. This may result in an aged/medically unwell pedestrian being unable to complete their ascent/descent.	2.1 As a high priority , liaise with MRWA and have handrails installed to both sides of the ramp [AS1428.1 2009 Clause 10.3(e)]. This is in acknowledgement that regardless of signs, pedestrian behaviour would indicate that pedestrians will continue to use the steep ramp.

3.	MRWA steep ramp is not furnished with warning TGSIs at the top or base.	The non-provision of warning TGSIs at the top or base of the steep ramp renders pedestrians who are blind or vision impaired uninformed of the steep ramp gradient.	3.1 As a high priority , liaise with MRWA and have warning TGSIs installed to the top and base of the ramp, with the TGSIs installed as per the rigours of AS1428.4.1 2009 for depth, set back from the ramp transition and luminance contrast.

4.	The MRWA steep ramp is not furnished with a kick rail to the open side of the ramp.	For a wheelchair user who loses control of their wheelchair in descent, impacting the vertical posts with the footplates of their wheelchair may result in the wheelchair tipping forward and the person falling forward out of their wheelchair.	If wheelchair access onto the ramp is prevented by the use of bollards, installation of a kerb rail would not be necessary.

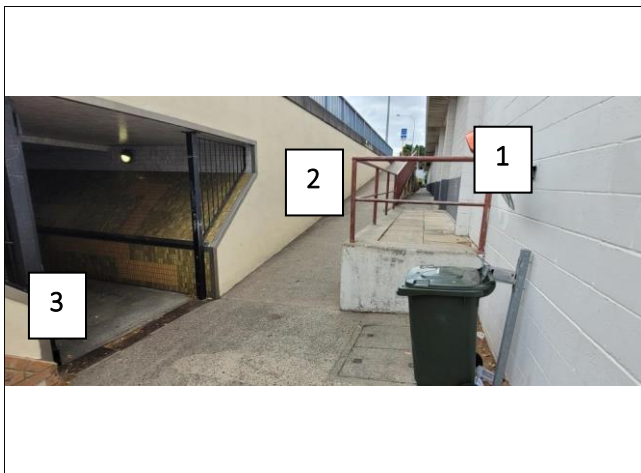
- There is a slab path to the rear of the Victoria Park Central [Vicinity] Shopping Centre that extends at the ground plane level across the rear of the Woolworths.
- The end of the slab path, located about 1m above the ground plane terminates near the western entrance to the underpass and base of the steep MRWA ramp [Refer to Figure 4].
- An assessment of the slab path condition was not undertaken, however on a cursory review of the photos taken of the path [refer to Figure 5], there may be some lips and gaps on the path surface.

Figure 4: End of slab path [1], ramp [2] & underpass [3]

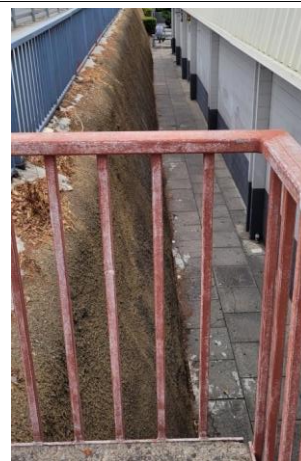
Figure 5: [Vicinity Centre] slab path may have minor lips and gaps

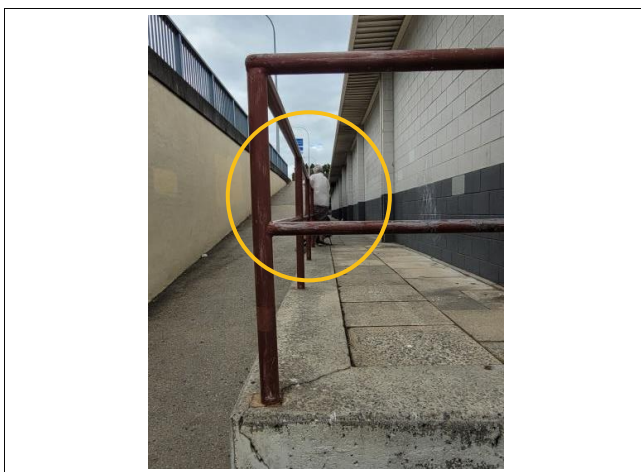
Due to the location and ease of access onto the slab path from the shopping centre pedestrians were observed to move between the steep sloped base of the MRWA ramp and the slab path by climbing between the open railing, including, concerningly, older persons [Figures 6 & 7].

Figure 6: Aged pedestrian with personal wheeled shopping trolley moves between open railings

7.	It is Mr Rankin’s observations that pedestrians using the “shortcut” are not wheelchair users but persons who are walking, typically carrying shopping, using a walking aid or are students handling their school bag.	<p>It appears that other than the 2017 incident, the pedestrians using the shortcut are people who are walking. Thus, the greatest risk pertains to them manoeuvring through the railings to take the shortcut.</p> <p>It remains that for persons who are ambulant, manoeuvring through the railing can still result in a fall or injury, or leave a person vulnerable whilst manipulating their shopping bags or the like.</p>	7.1 As a high priority , undertake one of the following: <ol style="list-style-type: none"> a. Install the pedestrian ramp as per Drawing M18-088 [Ramp and Handrail]. b. Retain the railing and construct steps off the end of the slab path in lieu of the pedestrian ramp. <p>Note: Mr Rankin had suggested opening the railings again and installing a bollard at the opening, to prevent wheelchair access but allow access for persons walking. This is a cost-friendly solution; however, with the uneven transition at this point, the construction of a compliant set of steps at the end of the slab path is my recommended/ preferred solution.</p>

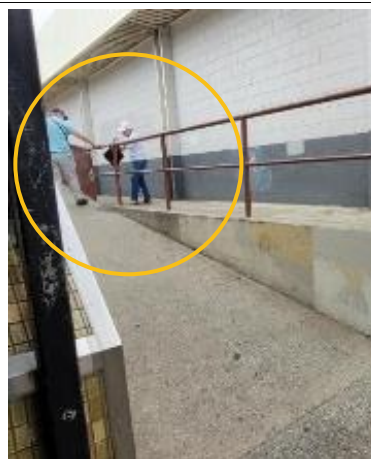
Figure 7: Two older pedestrians assist each other move between the open railings

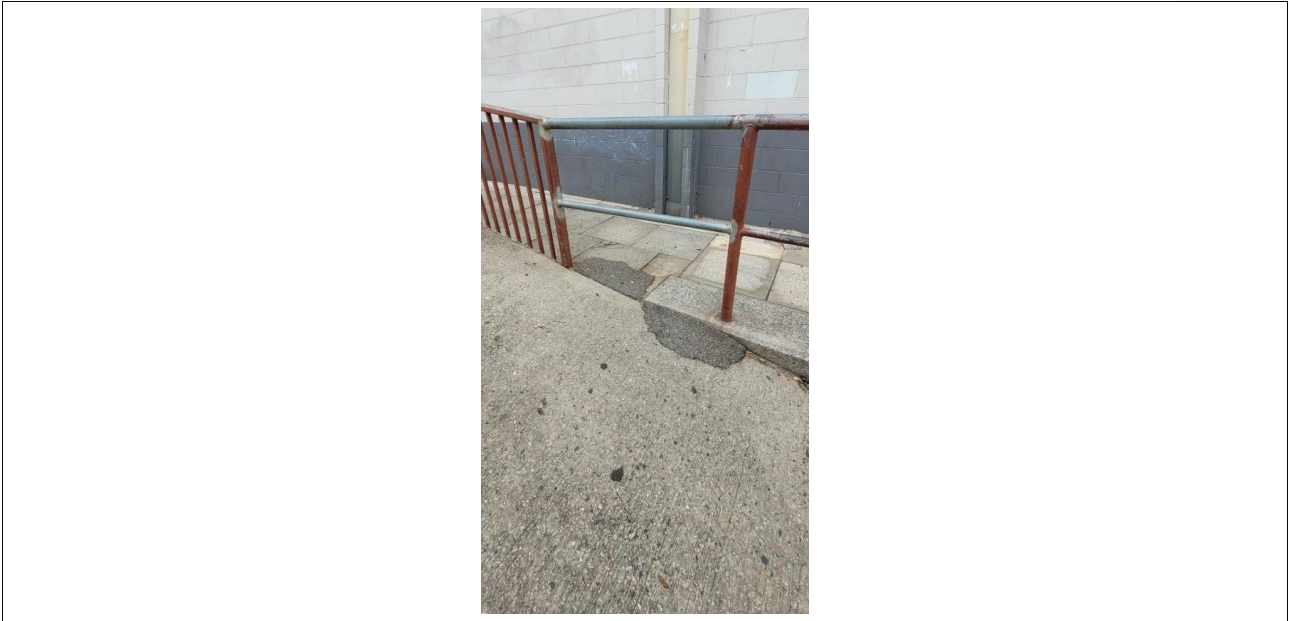
- This shortcut, presumably to create an accessway for pedestrians to and from the shopping centre, as shown in Figure 8 below, had also been furnished with a short bitumen ramp to transition the steep ramp and the slab path.

- Bitumen had been applied to the abutment between the horizontally level slab path and the abutting 1:14 slope. This does not address the non-compliance associated with wheelchair user movement between the ramp and slab path.

- Figure 8 shows the bitumen set between the ramp and slab path. This image also shows the railings that had previously been removed and reinstated. Thus, at this time, wheelchair access is not possible between the steep ramp and the slab path.

Figure 8: Retained bitumen at the abutment between the slab path and steep ramp, railing in situ

5.	There is an improvised bitumen transition between the MRWA steep ramp and slab path	The transition between the steep ramp and slab path constructed crudely from bitumen, if the railings were open at this transition point, would pose a significant risk to a wheelchair	Remove small bitumen transition "ramp".
