**HOCKING
HERITAGE +
ARCHITECTURE**

**Edward Millen Home (fmr) Victoria Park
Heritage Impact Statement for Demolition of Hillview
Clinic Building
March 2023**

HHA Job No. 2022-48

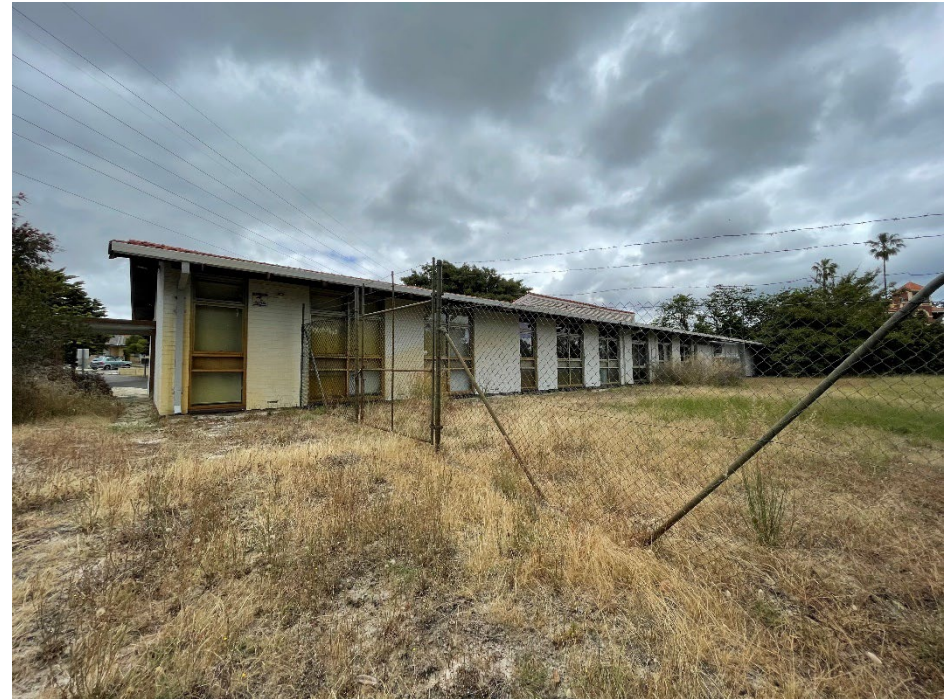
Figure 5: North elevation

The building was constructed in the 1960s in a lineal form and is of simple architectural expression. The main feature of the building is the regular rhythm of fenestration along the north and south elevations.

The roof is a shallow pitched gable roof clad with terracotta tiles. A raised section of roof is positioned within the centre of the building with gridded facing towards the north. The southern plane of the vent is the tiled continuation of the roof creating a seamless aesthetic to the element. The eaves are open and overhang the north and south elevations providing some degree of shade.

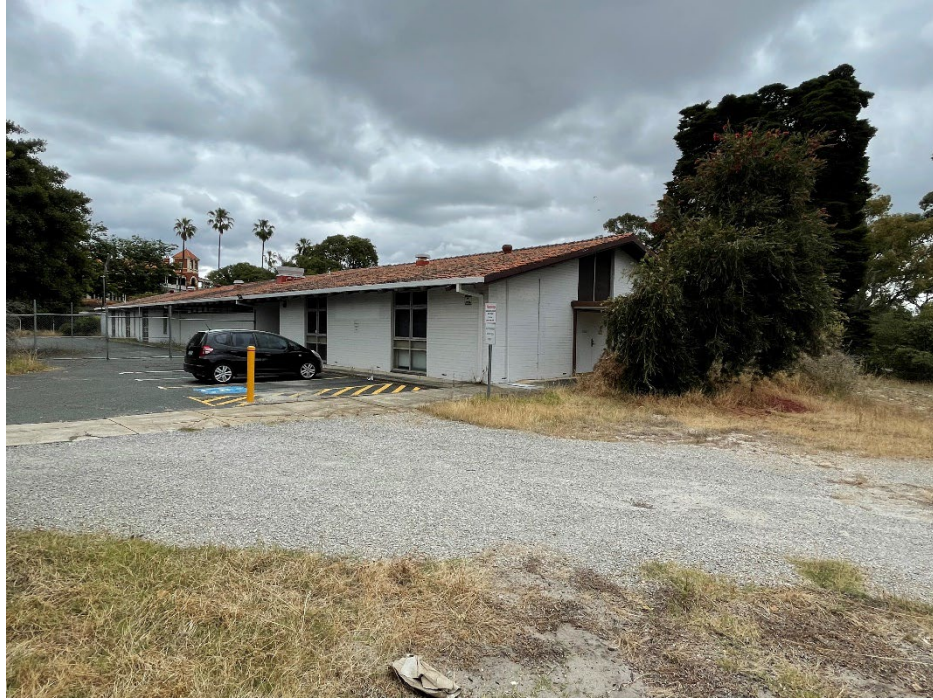
Figure 6: South and east elevations

The brickwork has been painted white which provides a contrast to the terracotta tiled roof. A covered entrance is located at the eastern end of the building with flush panel double doors and large window above the flat canopy. There is a double door entrance at the western end of the south elevation, set back behind the main building line and a further recessed entrance with sliding aluminium doors is located on the south side of the building, towards the eastern end of the elevation, opening into the car parking area.

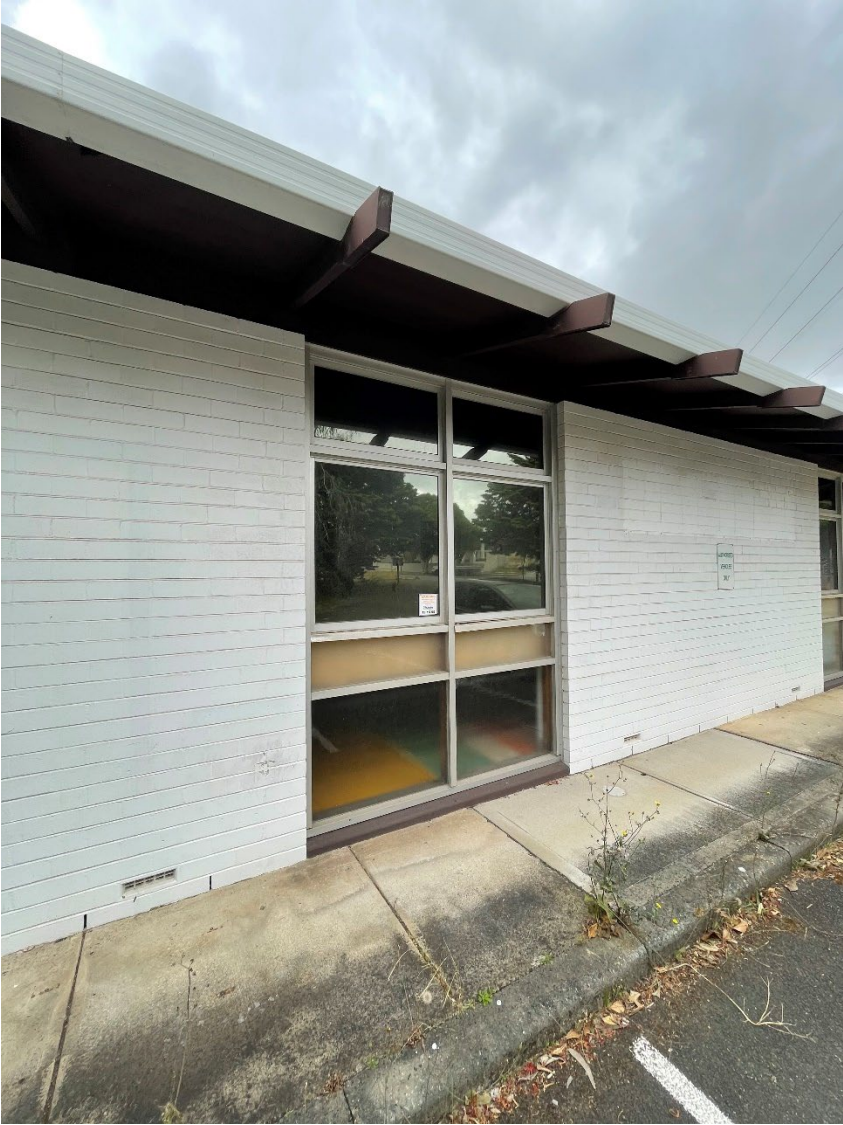
Figure 8: Typical window detail

The windows are full height aluminium openings, each divided into three glazed sections together with a mid-height solid panel. A bank of high level windows on the south elevation indicate the location of the bathrooms.

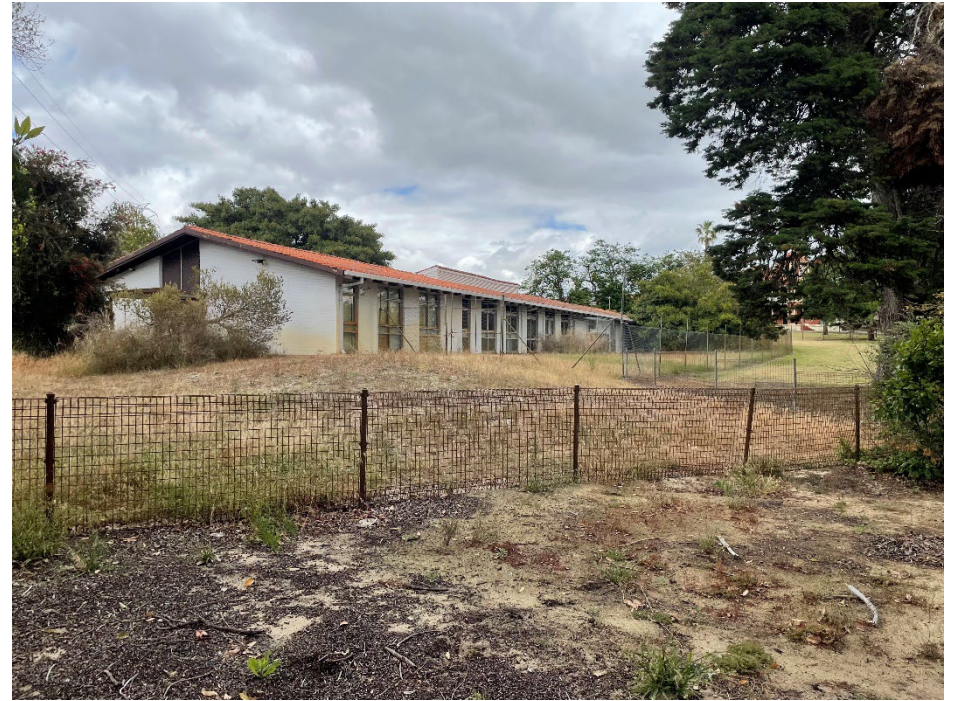
Figure 11: North elevation

The former Hillview Clinic building is a single storey building of brick and tile construction. The building is positioned close to the Hill View Terrace boundary and positioned at a diagonal to the main buildings, planned on an east-west axis in a landscaped setting.

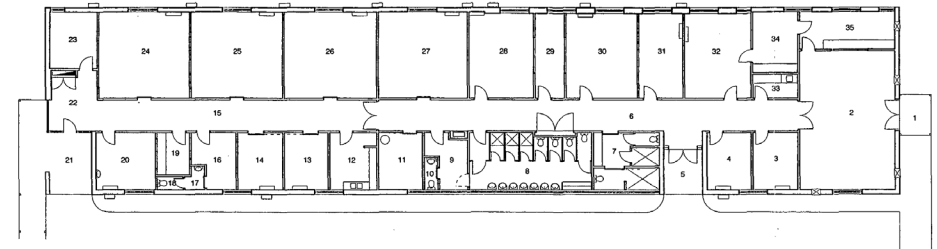
Internally, the Hillview Clinic has been divided into a series of office spaces. Plans included in the 2001 conservation plan show the space divided into a number of large rooms along the northern side of the building accessed from a central corridor which extended along the majority of the length of the building and terminated at the biggest of the rooms at the eastern end. Smaller rooms and washrooms and other ancillary accommodation was occupied the southern side of the building. It is assumed that this was the original internal planform of Hillview Clinic.

Figure 13: Internal planform of Hillview Clinic c.2001
Courtesy: Hillview, Victoria Park – Conservation Plan, July 2001, Considine and Griffiths Architects with Robin Chinnery, Historian

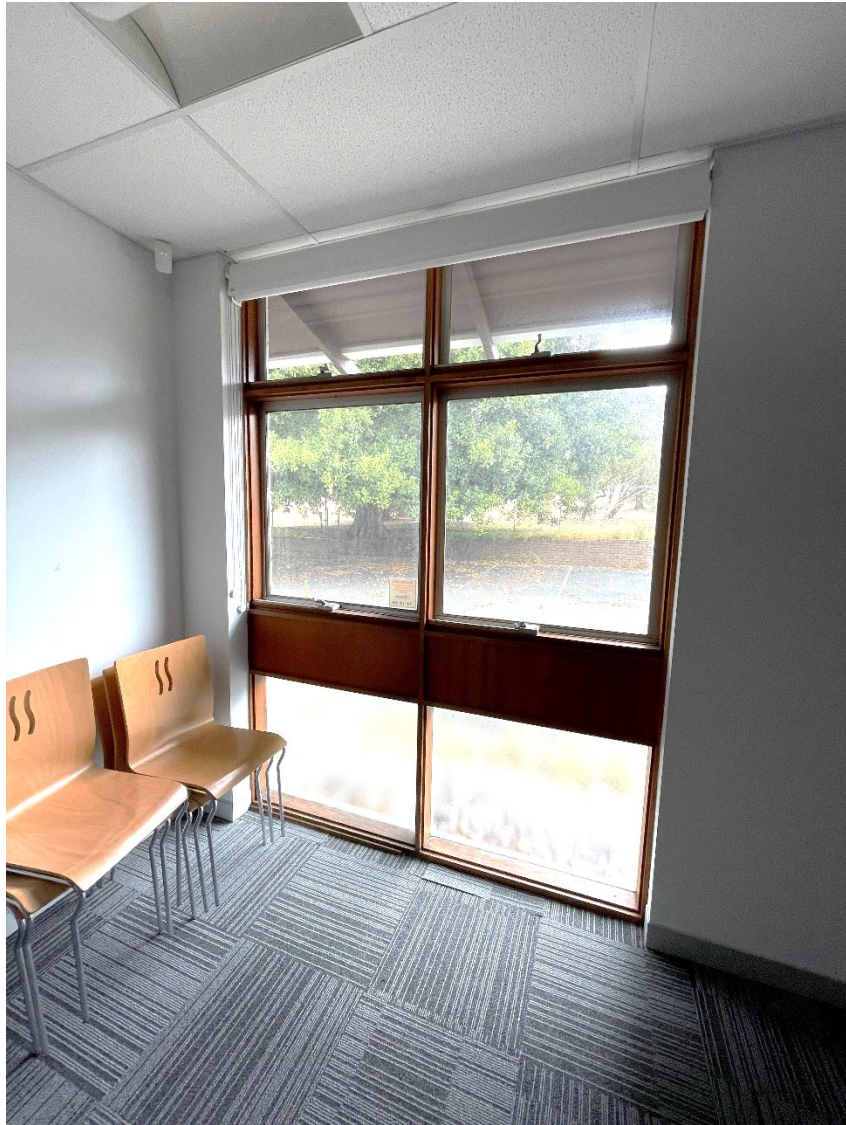
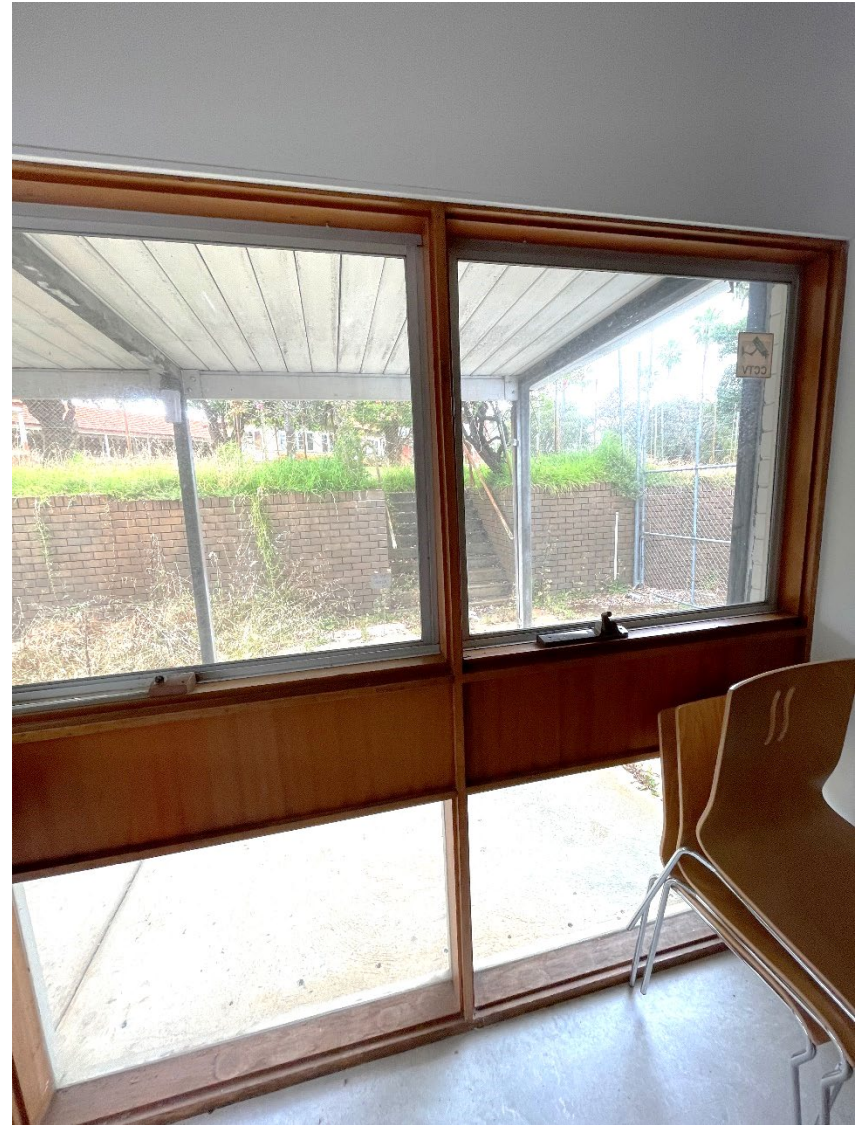
The original timber lining to the windows were retained as part of the works.
